Drakes Estero eelgrass, oyster bag, and oyster rack assessment Trip Report - 3/20/2007

Oyster rack, bag, line and eelgrass assessment

Eelgrass satellite imagery ground truthing

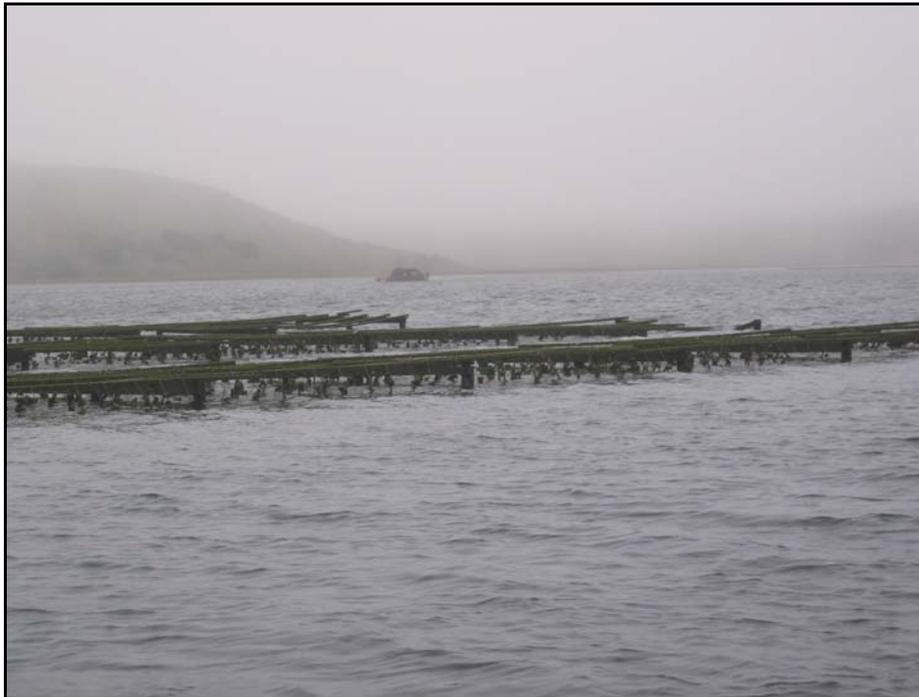
Active oyster racks in Drakes Estero.

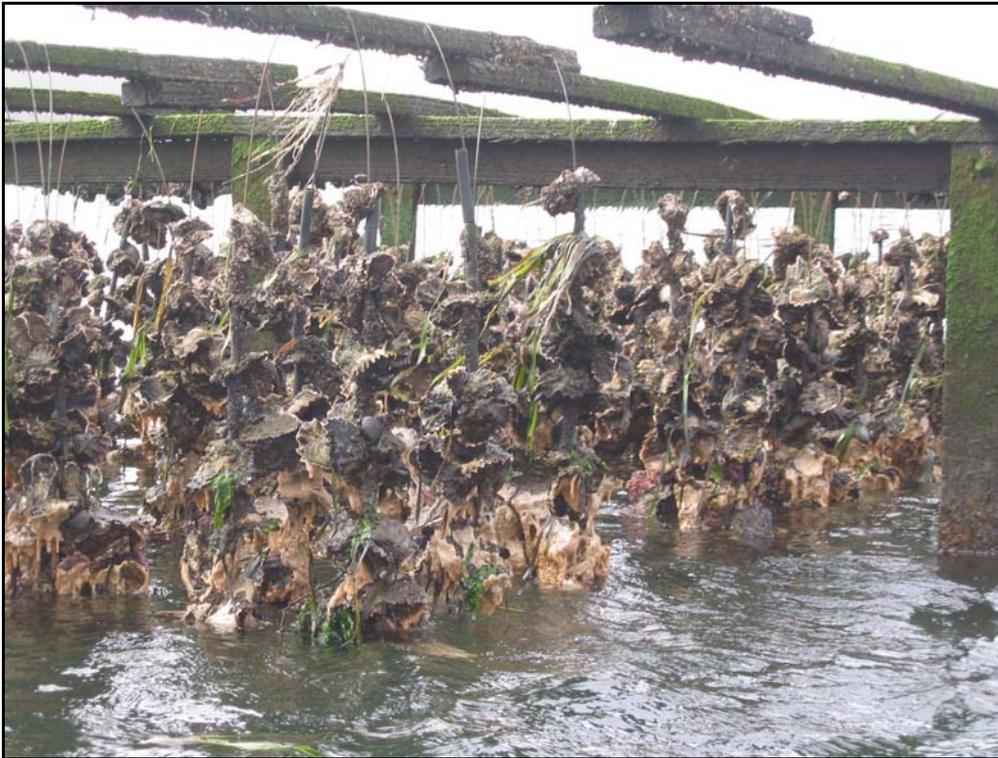
Most of the apparently older and larger oysters growing on racks had extensive non-native, highly invasive tunicates (*Didemnum* Species A) growing on them (See images). This species is an aggressive invader that has had substantial ecosystem and financial impacts in New Zealand, several west coast estuaries and the Grand Banks off Newfoundland. Other fouling organisms (native and non-native sponges, tunicates, bryozoans, and mussels) were observed on both oysters and racks throughout the estuary.

Non-native tunicates (*Didemnum* spp. A) growing on oysters.

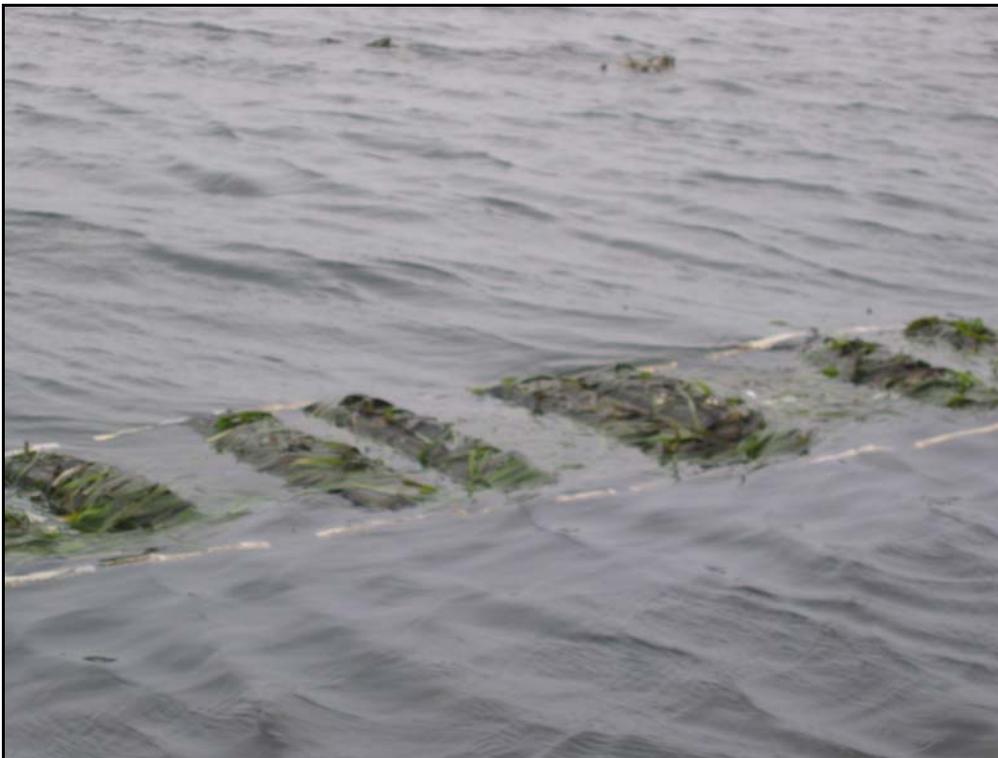
Floating bag system tethered by ropes.

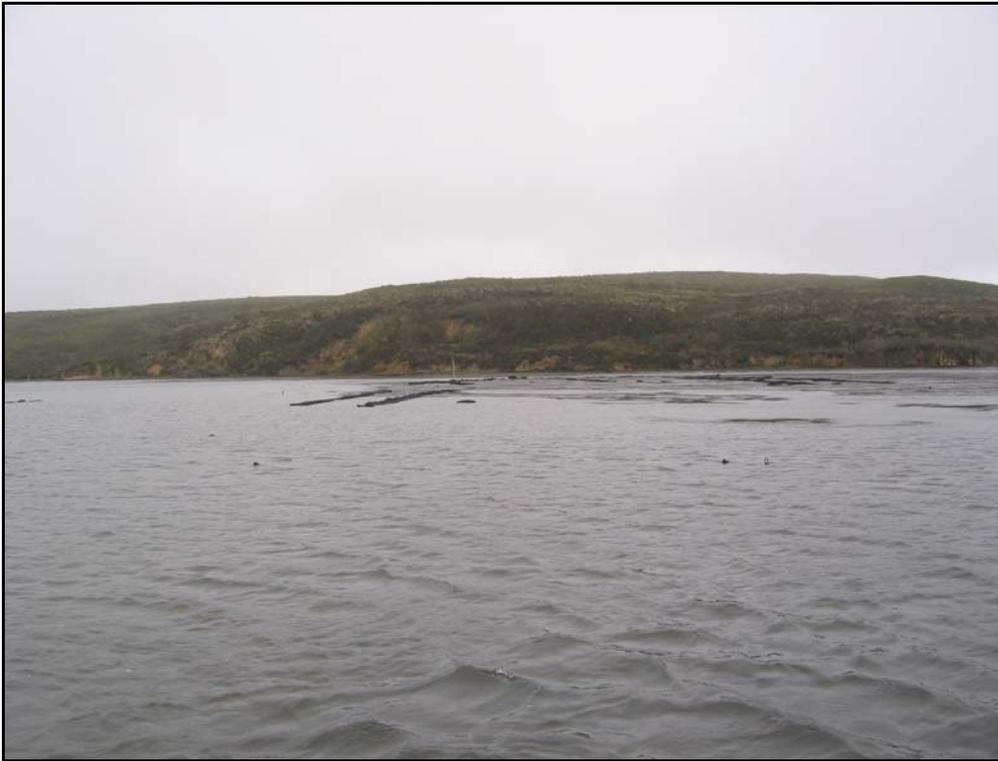
Tethered oyster bags on intertidal sand/mudflats

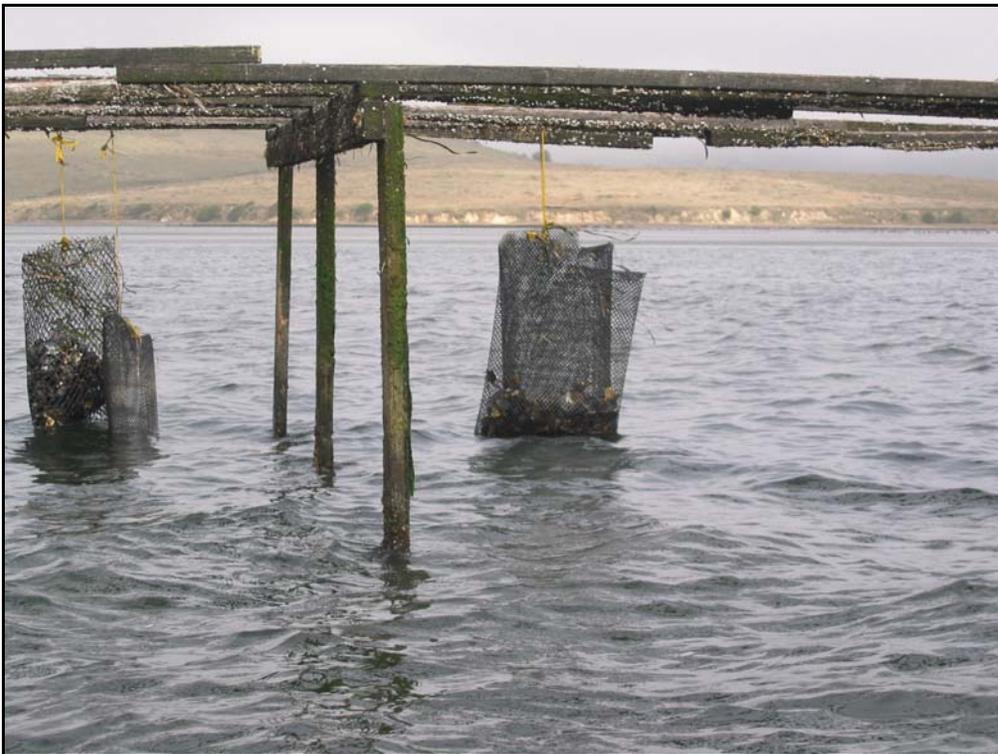
Hanging bag array
